GPS Time Disruptions on 26-Jan-2016

Metsähovi Radio Observatory

Aalto University publication series

19. February 2016

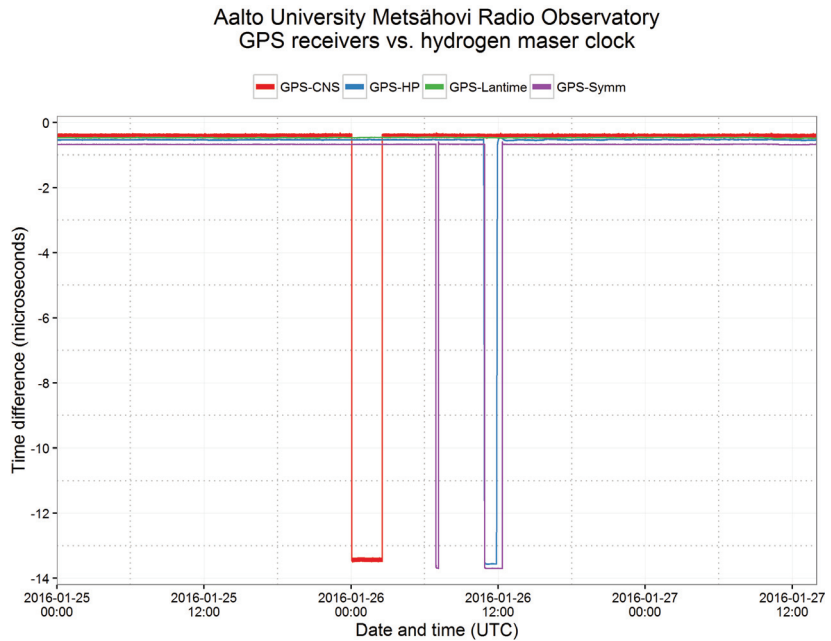
On Tuesday, January 26th 2016 the automated Nagios alarm triggered and warned that Metsähovi H maser atomic clock time is off by 13.0 microseconds. After inspecting “clodi”-based time comparison data it was all too clear that both the primary and the secondary H maser clock were keeping the correct time without any abrupt jumps. Instead, three out of four Metsähovi GPS receivers were randomly outputting time which was 13.0 microseconds off. All the receivers were not simultaneously outputting wrong time, instead, different receiver models were off at different times, as depicted in Figure 2.

Figure 2. Time difference between Metsähovi H maser and four different GPS receivers.

The timeline described in the report did not fit well with observed GPS time disturbances. The satellite “PRN32/SVN23”, one of the oldest in the current GPS constellation, over 25 years, had failed already on 25-Jan-2016 at 15:36 UTC and it was remotely shut down and decommissioned on 25-Jan-2016 at 22:00 UTC. At that time there were no anomalies in Metsähovi GPS monitoring system, as can be seen in Figure 2.

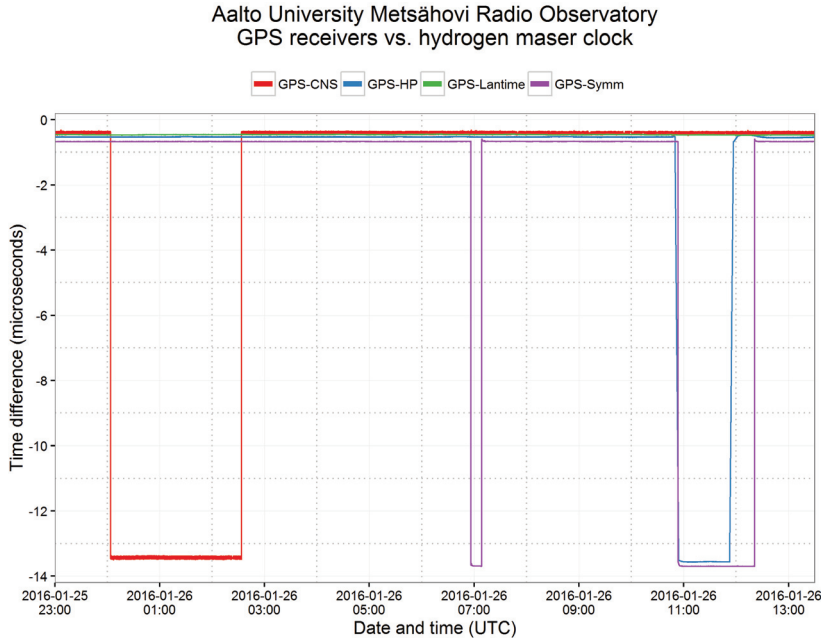
Figure 3. A detailed plot of the time difference between Metsähovi H maser and four different GPS receivers, for the duration of disruption only.
